# Lessons Learned from UV System Performance Audits for Reuse Applications

Traci Brooks,\* Harold Wright, Andy Salvesson and Mark Heath

Carollo Engineers, Inc., 1218 Third Avenue, Suite 1600, Seattle, WA 98101

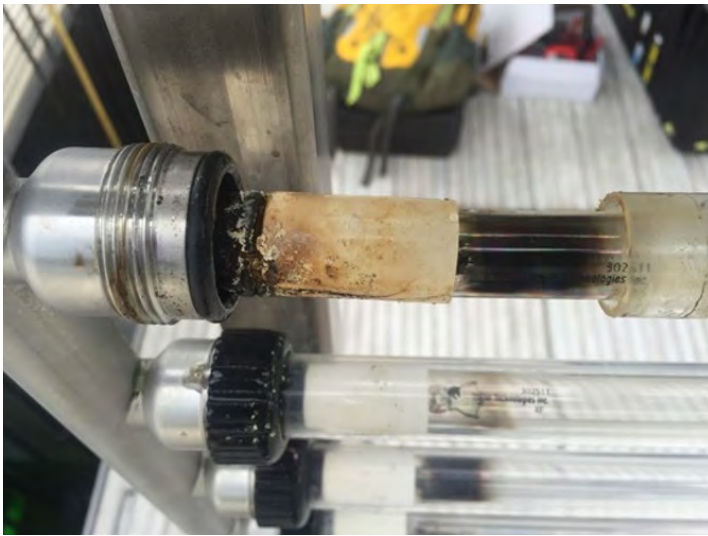
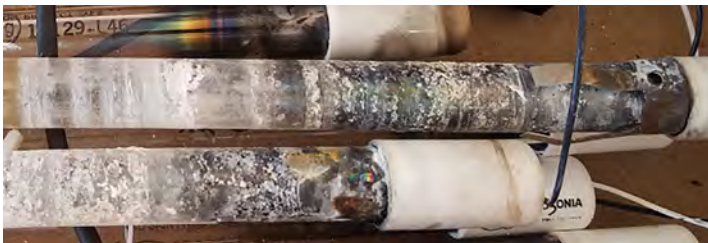
Algal growth was seen at many of the locations but did not seem to interfere with the UV system performance. Lamp end darkening and corrosion were seen at several locations (Figure 1). This can occur when water gets in the sleeves during a lamp or sleeve change and can cause lamp failures.

**Figure 1.** Lamp end darkening and corrosion

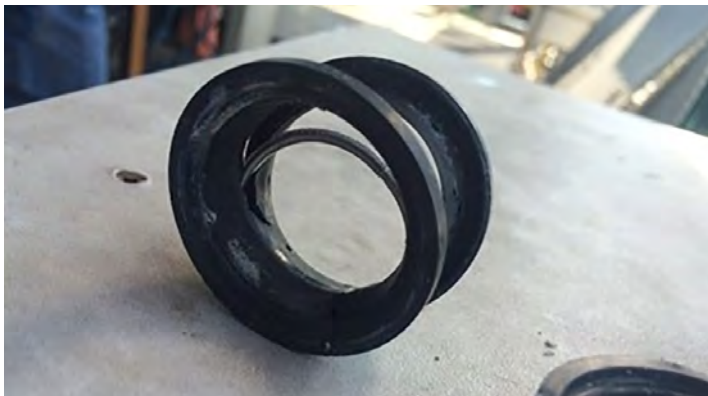
One location had significant damage of wiper seals that exposed the spring used to maintain pressure on the sleeve (Figure 2). The operators reported that during operation, the wiper cleaning fluid may have leaked out, causing wear of the wiper seal and the spring breaking through. Once the wiper seals had worn through, the exposed spring scratched the quartz sleeve, and in some cases, the exposed spring grabbed the quartz sleeve, pulling it out of its attachment point at the end of the lamp module, allowing water to enter the sleeve and causing lamp failures.

**Figure 2.** Broken wiper seals with exposed springs

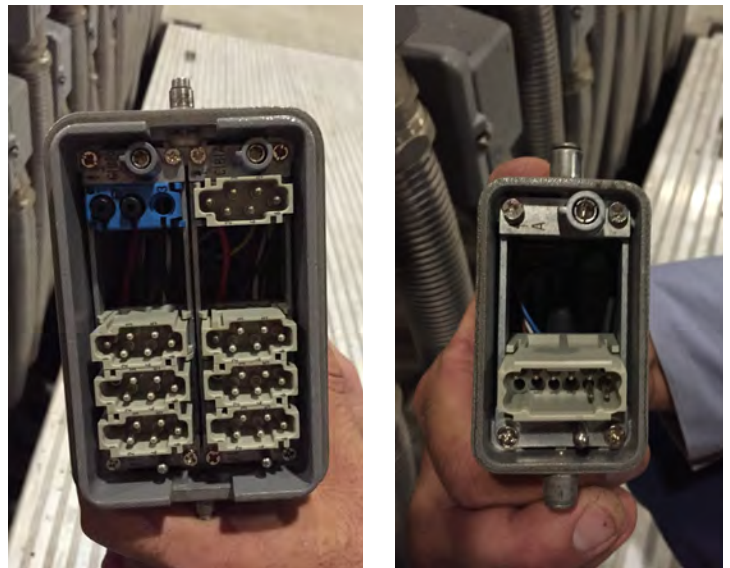
At a few locations there were issues with lamp and sensor connections, as well as clearance issues, when removing modules from the channel that were noted by the operators. Figure 3 shows that the electrical connections to the reactors had some open spaces that allowed for possible misalignment when reconnecting. This led to some mechanical failures of the plug that the vendor had to address. Figure 4 (on page 6) shows some clearance issues encountered when trying to remove modules from the channel for maintenance. In these systems, the outside modules could not be removed without also removing the adjacent modules because part of the bank frame was in the way.

**Figure 3.** Loose lamp and sensor cable connections

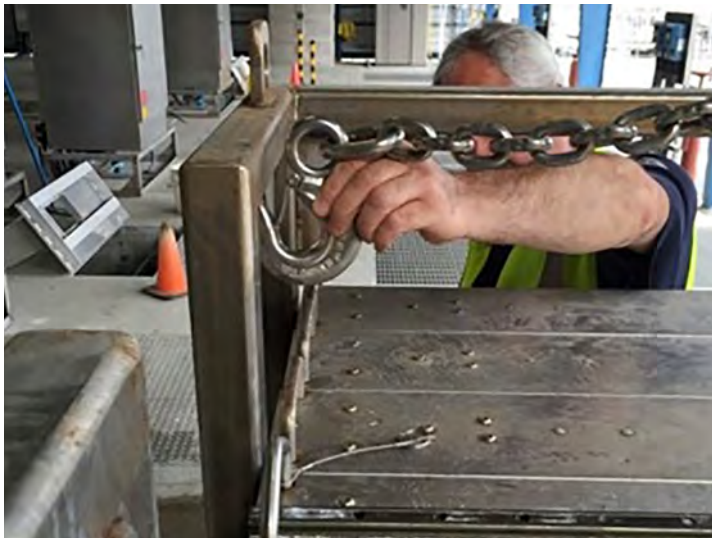
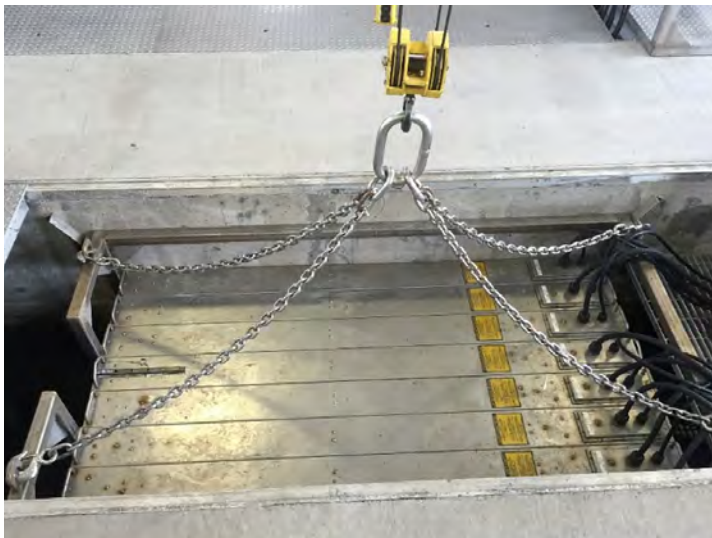
**Figure 4.** Clearance issues when removing modules

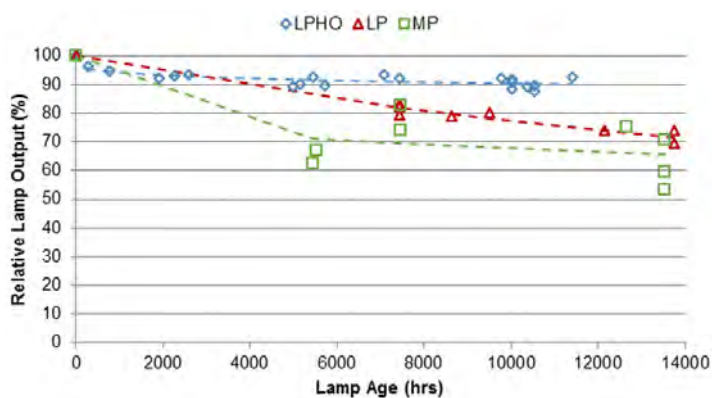
The lamp aging curve shown for the LPHO lamp was consistent for a variety of systems and vendors. The curve starts out at 100 percent for new lamps followed by a steep drop in relative lamp output to around 90 percent at which point it levels off until the end of lamp life around 12,000 hours. The MP lamp aging curve shows a sharper decrease in the relative lamp output in the first 5,000 hour before leveling off around 65 percent. The LP lamp aging curve shows a steady decrease in the relative lamp output down to 70 percent after 14,000 hours.

**Figure 6.** Lamp aging curves for LPHO UV systems
